Case Study

South London Mews Property

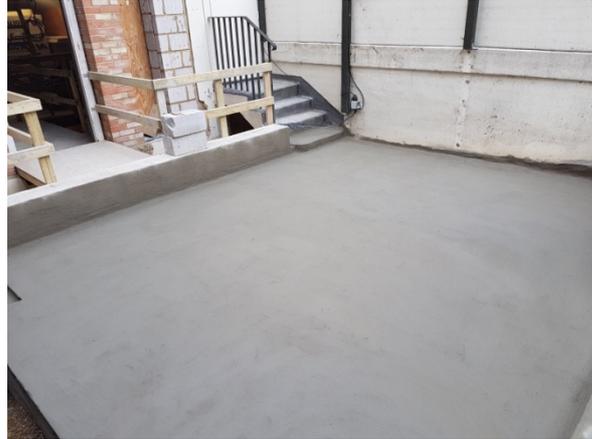
The project required the newly extended/excavated basement to be made watertight with a waterproofing system which provides a Grade 3 waterproof environment (in accordance with Table 2 BS8102:2009).

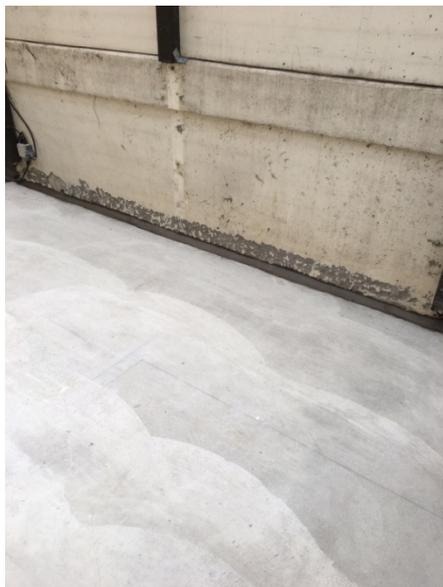
The area of potential weakness (where moisture could penetrate into a structure) in a below ground structure is the wall/floor junction.

Delta's Waterproofing Design Specialist alongside Advances Simon Wootton CSRT CSSW A.INST I.S.S.E suggested incorporating Köster NB1 to wall/floor joints (where the masonry walls meet the concrete slab).

For external junctions, fillets were created using Köster Repair Mortar Plus (a unique expanding waterproof material) to keep important junctions protected and watertight. The

coved fillets were further waterproofed using two coats of Köster NB1 crystallizing mineral waterproofing slurry. Insulation screed and further fillets were incorporated to create a robust

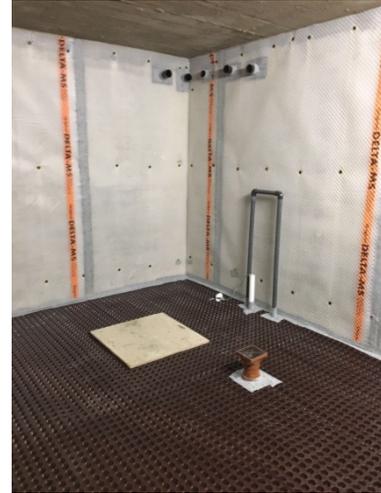
- Koster NB1
- Delta MS20
- Delta MS500

Delta MS500 and MS20 - NBS Specification J40 (Clause 290)
Flexible Sheet Tanking/Damp proofing. BS 8102:2009 Type C
Drained Protection.
